## Headcode display at both ends

More metalwork repaired on 79443 and pass. comm. mechanism takes shape. Main structure of shelter built. 51017 now displays a headcode.

## WORK REPORT to 31st March 2011

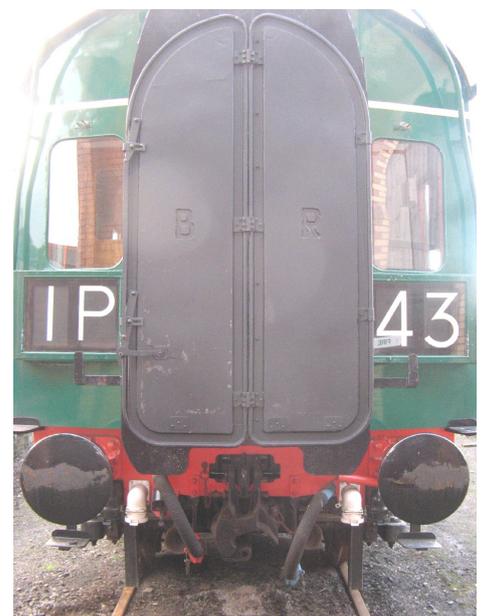
**Right.** The headcode blinds make a big improvement to the front end of 51017. It looks fatter here due to the difficulty of taking photos showing the full height while being squashed up against the running shed door!

The most obvious Work Week work occurred in 51017 – it now has a full set of headcode blinds! Many parts of the mechanisms were missing when the unit was purchased from BR but James Robertson (SRPS) recently turned new end fittings (and supplied rod for new guides) and new rollers were fabricated by cutting up spare rollers from EMU destination screens (supplied by Alastair Cowan, Diesel Group). Once a set of eight had been made we began trimming the blinds to fit the space in the headcode display boxes.

We have two types of character blinds: one is cloth with 8"-wide characters; the other plastic with 7" ones. Ayrshire Swindons should have 7" characters but we decided to use cloth as we do not have a full set in plastic and wanted all character positions to be the same size. This meant that the full length of each blind had to be trimmed down both sides to fit inside the headcode screens. After filing out the square drive hole and rolling the second position blind tightly on to the first pair of rollers, it was fitted as a test. It was OK but the characters are a bit too wide. The other three blinds were then cut to width and the same work done to fit these too. These "lovely little things" make a big difference to the cab front. Headcodes should be changed by turning winders in the cab and second-man areas but we will have to turn the

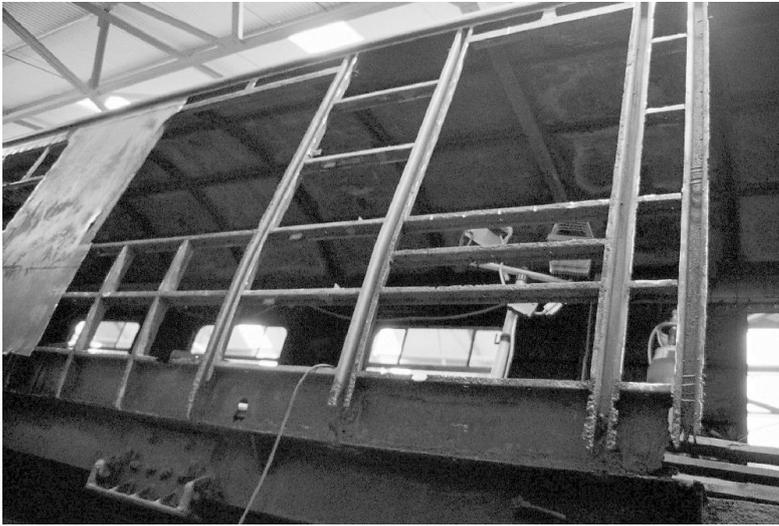
79443's compartment side after removal of panels around the toilet and compartment A windows. Photo: John Miller, 6th February 2011.

Apart from a small section below the gutter, all panelling has been removed from door 4 to the far edge of compartment A's window (no. 15). As well as cutting through the panels, welds have to be ground off from inside or outside, depending on ease of access. Primer was applied to the resulting bare metal on the framework. The vehicle's number (for both green liveries) is on the lower panel between windows 15 and 16 (passenger lavatory). Careful sanding was done to

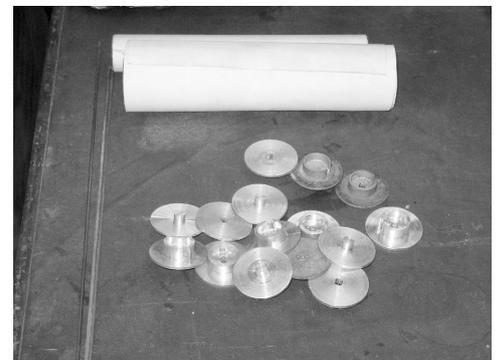
Some component parts for 51017's headcode blinds: end fittings, guides and the rolled-up blinds. Photo: John Horne, 25th January 2011.

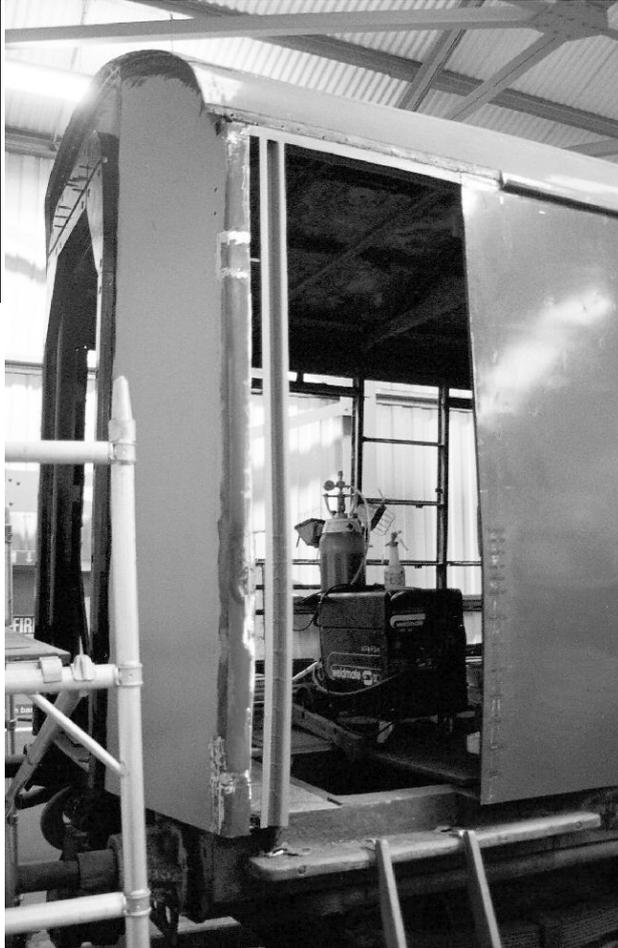
**Right.** The new corner plates and door pillar on 79443. The plate above the door has also been replaced. Photo: John Miller, 6th February 2011.

Just before the Work Week all parts (many large and heavy) stored in the workshop at the No. 1 end of 443 were moved out of the way so that scaffolding could be erected to enable us to progress the rebuild of the bodywork. Door 1's (corridor side) rotten pillar was cut out and a new one welded on. It, along with an as-yet-unfitted new top hat section for door 4, had previously been formed to the correct profile from straight top-hat section using the same technique used to shape the roof end L-section. Once in place the edge was ground away to match the original. The corner framework was cleaned up then two new pieces of plate cut and welded on to cover the gap between the new pillar and the corner. We removed the gutter from above the door then cut out and repaired the rotten metalwork underneath it. Old sealant and corrosion was removed from the back of that length of gutter and both end pieces (removed from No. 1 end a while ago). They were then primed and painted on the reverse only. New panels for the bodywork between the corner and door 1 and above that door have been made, painted (reverse only) and welded onto the new framework (also painted). The curve at the bottom of that corner was also corrected. Nuts for the water filler pipe on the corner of No. 1 end were replaced. The pipe and lower bracket were cleaned up with a wire-cup brush then

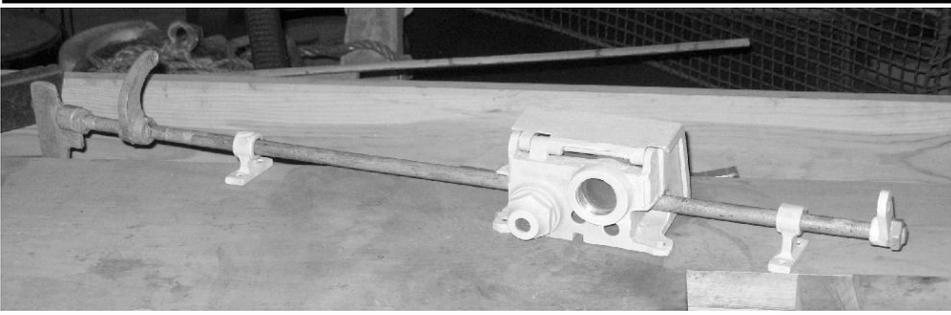
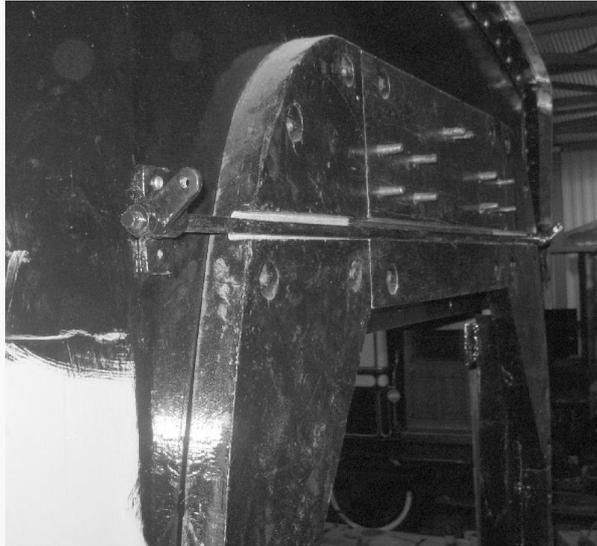
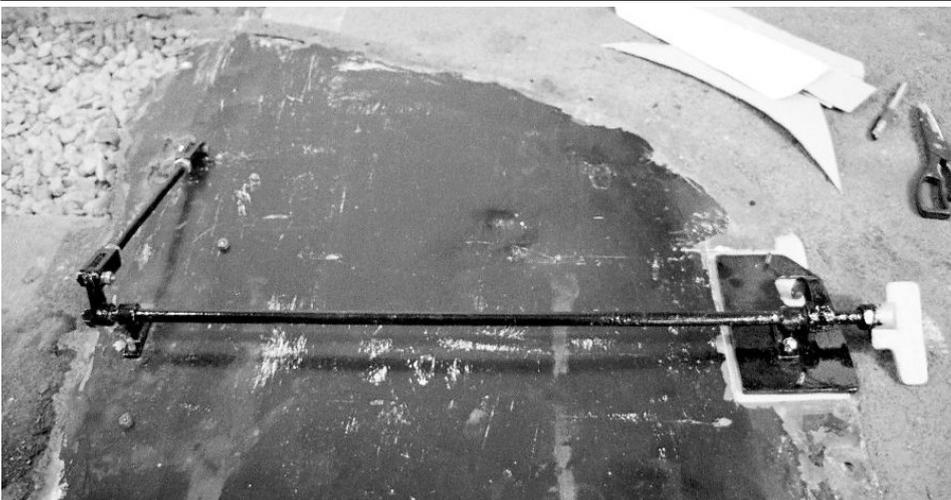
These photos show most of the passenger communication mechanism to be fitted to 79443's No. 1 end. **Top.** The left-hand rod holds the valve box that opens to destroy the vacuum when the chain is pulled. The chain is attached to the horn near to the flag at the left-hand end of the rod. Photo: John Horne, 20th February 2011.

**Middle.** The centre section allows the chain on the other side of the carriage to operate the valve. Each end connects to a short vertical rod as seen below. Photo: John Horne, 28th January 2011.

**Bottom.** The right-hand rod and the vertical section that connects it to the centre section above the gangway. The linkage and butterfly plate have been placed on the original panel to determine exact positions. The hole in the base plate allows the chain to connect with the mechanism. Photo: John Miller, 6th February 2011.

centre part of the operating linkage through the slots in the gangway timber showed that the slot was not deep enough on one side. A chisel was used to rectify this and allow the bracket to be mounted on that end without the linkage fouling the timber. Inspection and measuring of a mark 1 coach end helped this work. A template was made from the surviving section of original end panelling to establish positions for the pass. comm. linkage bracket studs. The long linkage was fitted temporarily and this revealed that more chiselling of the gangway timber was needed to allow it to rotate freely. Once that was done the holes for the lower bracket studs were marked and drilled (after a dry run assembly and checking of

the 3-car unit ends). A second template was made to work out the approximate position of the linkage and butterfly mounting plate on the corridor side of No. 1 end. The plate's position was marked using the original holes in the template then the vertical position was adjusted until they lined up accurately with the hole for the chain, linkage position and roof curvature. The template was reversed and the same procedure repeated

on the other side. The compartment side linkage and valve were trial-fitted and lined up exactly with the marked positions so the hole for the chain was opened out using a file to match the newly-established plate position. The new L-section roof/end join fouls the butterfly plates so the excess was ground away. The section of pass. comm. rod with the valve box attached was slightly bent so the clamp was released and the box moved along the rod, clear of the bend. It was then heated and straightened. This assembly is from a Mark 1 carriage as 443's was missing when it was purchased. The rod, valve box and cover were then thoroughly cleaned, removing layers of dirt and paint, and the whole assembly primed. We had kept the piece of original end panel with the valve box plate attached. Its position on the new panel was determined by drilling reference holes through the original, mounting it over the foot-

step studs then marking and joining up hole positions on the end sheeting. Checking showed that the positions of adjacent bracket studs were slightly out so they were corrected and the valve and linkage trial-fitted. This showed that the plate (that the domed butterfly cover fits on to) had to be moved slightly. The hole for the other chain was enlarged to line up with the hole in the plate once its exact position was confirmed. The butterfly mounting plate was removed from the original end panel only after heating stubborn nuts. The valve box was moved back to its correct position, using the mounting studs on the original bodywork for reference. Its mounting plate was cut out of the original bodywork and cleaned

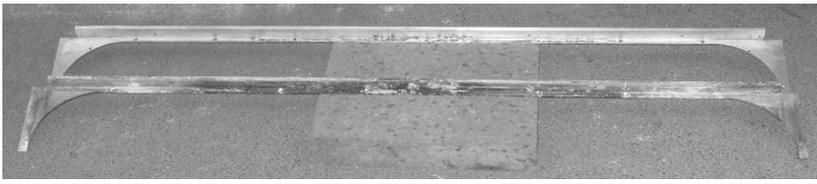
E&G alloy window fittings before and after cleaning. They fit just above the main window unit. Photo: John Horne, 27th January 2011.

Edinburgh – Glasgow windows were built to a different design from the Ayrshire ones. E&G vehicles have an additional alloy piece that is shaped to fit directly around the top of the main window unit and the top sliding light guide is attached to it. This is more elaborate so perhaps this was altered to save money in the later build. Ayrshire stock has the sliding light guide attached to hidden timber and uses only a small piece of Formica to fill the gap at each top corner. As the corners and sliding light guide are visible, we have cleaned and polished many of these pieces from the windows that have been removed so far plus other alloy interior trim for the kitchen and buffet areas. Some have had remains of broken screws removed. The four refitted window units had been attached using standard nuts and bolts but those along the top need to be flush with the window unit to allow the sliding lights to go back on. We have now made the correct countersunk nuts (pre-cleaned and re-threaded) so a four-stage process was used to fit them (see diagram on page 6):

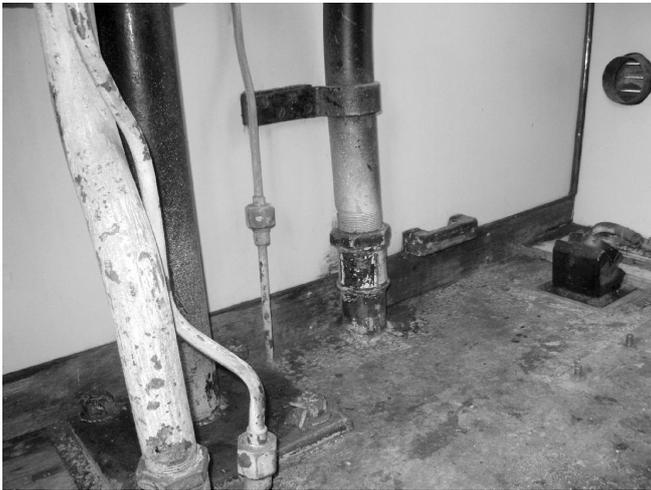
The back wall of 51017's cab has been cleaned. The various pipes and conduits are next to be done. Photo: John Horne, 25th January 2011.

Newly-varnished beading was fitted in the corner of 17's cab, behind the driver. This entailed removal of the seat so the opportunity was taken to properly sort out the back wall area. The skirting board and final drive key support were sanded,

the wall panels cleaned and work to remove rust, flaking paint and dirt from pipework and fittings began. The small heating vent in one corner was badly bent so it was removed, cleaned, polished and reshaped. So far, the drive key support block on the rear wall of the cab has had red undercoat and gloss, there is one coat of varnish on the skirting board and some

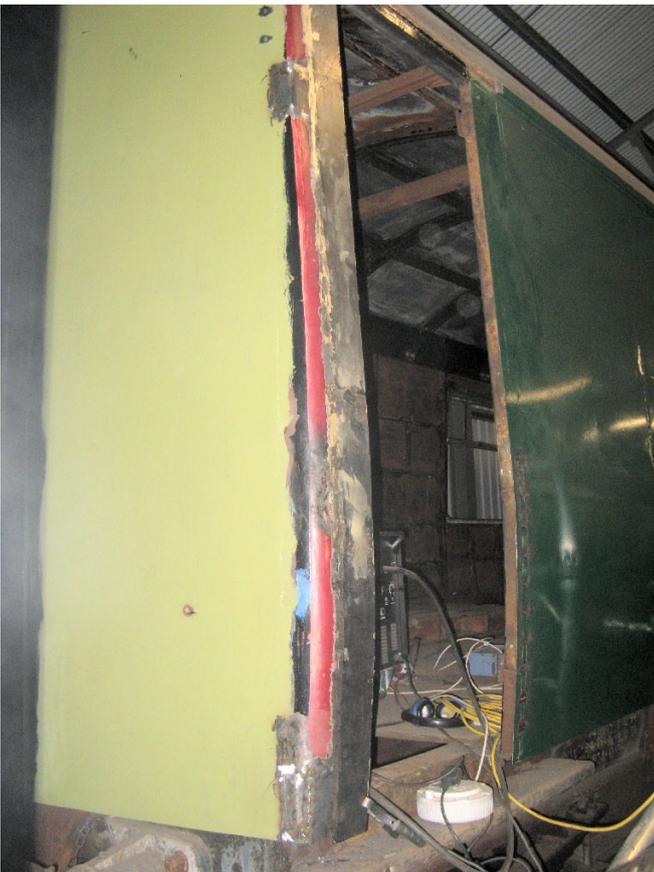
stored temporarily on the restored door. Doing this revealed areas of blue and grey paint plus white and yellow tape and tells us that these edging strips (fitted to reduce corrosion at the doors) were added

later than we thought (see page 8). We had assumed this was done in the green era. The timber underneath was then removed as carefully as possible. Some original wooden trim and wall panelling survived inside at door 4. They were carefully removed after photography in situ and will be used as a basis for new trim and veneered walls at that end of the carriage.

**Below.** Newly-revealed details at 79443's door 4 after removal of the alloy strip down the left-hand side of the opening. It was covering the first blue and grey livery with yellow first-class band. Some green is visible under the yellow. Green-era lining can be seen to the left, under the white tape separating the blue (or yellow) and grey.

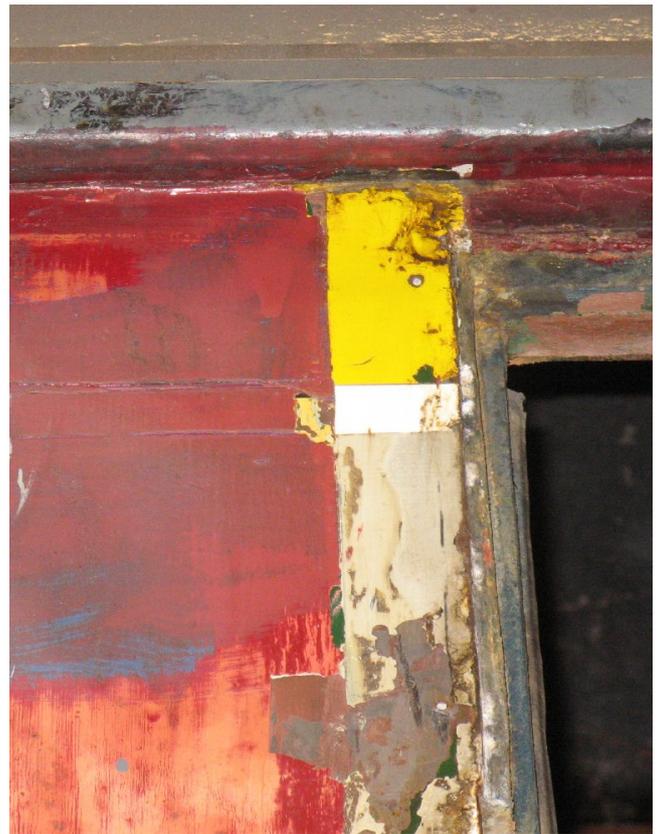
**Above.** The No. 1 end/corridor side corner of 79443. Door 1's pillar and the section above the doorway have been replaced and new sheeting welded over that.
